# Manhole Inspection Summary

Manhole # S04CC2018MH

Insp Date: **7/19/06 12:06 PM**

**Location** Address: **3505 LABYRINTH RD**

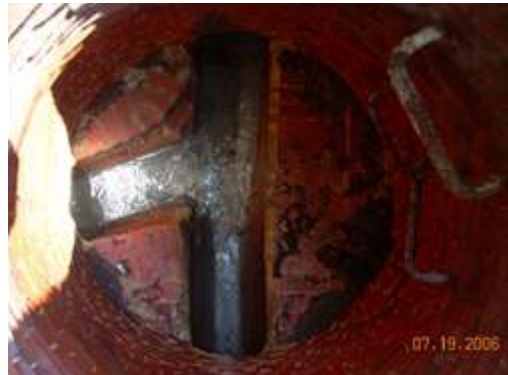
Top View

Corroded steps. Bench debris.

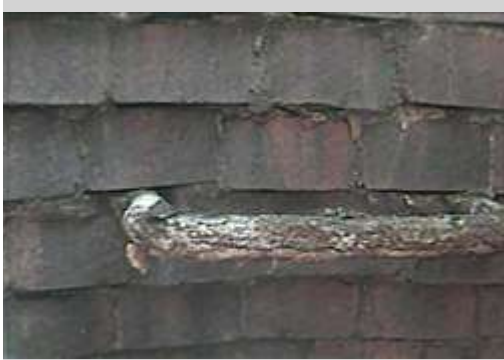
Defect

Corroded steps.

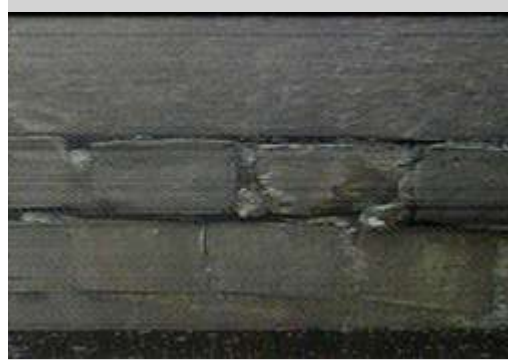
Defect

Frame leaks. Adjustment loose brick and cracks. Adjustment infiltration.

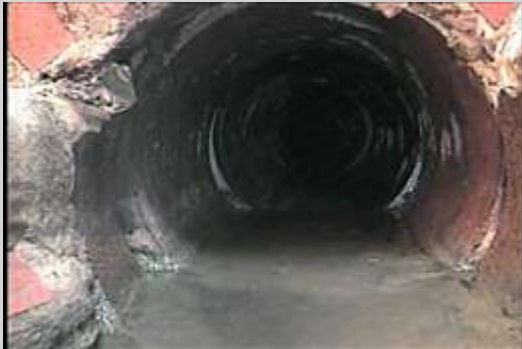
### 12 in. Circular Gravity Sewer Pipe Out @ 12 O'Clock

Deposits: ☐ None ☐ Mud ☐ Sludge ☐ Debris ☒ **Grease**

Silt Depth: **0** (in.) Deposits Extent: **Light**

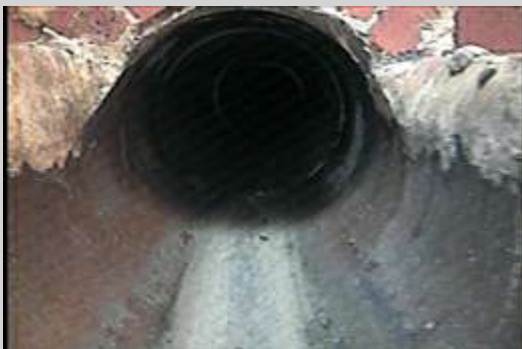
### 12 in. Circular Gravity Sewer Pipe In @ 6 O'Clock

Deposits: ☐ None ☐ Mud ☐ Sludge ☐ Debris ☒ **Grease**

Silt Depth: **0** (in.) Deposits Extent: **Light**

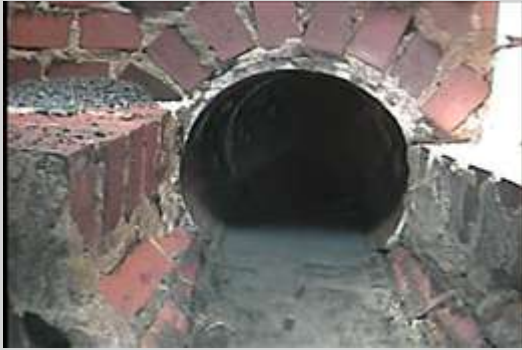
Pipe In @ 9 O'Clock

Deposits: ☐ None ☐ Mud ☐ Sludge ☐ Debris ☒ **Grease**

Infiltration: **Evidence**
